Re: Conditional Use Permit Application for: Old Glebe Point, LLC – VAL029 Old Glebe Point Project

MODULE 1: PROJECT DESCRIPTION
MODULE 2: PRELIMINARY SITE PLAN PACKAGE
MODULE 3: STORMWATER MANAGEMENT PLAN
MODULE 4: MAJOR WATER QUALITY IMPACT ASSESSMENT
MODULE 5: 200-FOOT SETBACK REDUCTION NARRATIVE
MODULE 6: EMERGENCY RESPONSE PLAN
MODULE 7: DECOMMISSIONING PLAN

VAL029- Old Glebe Point Project

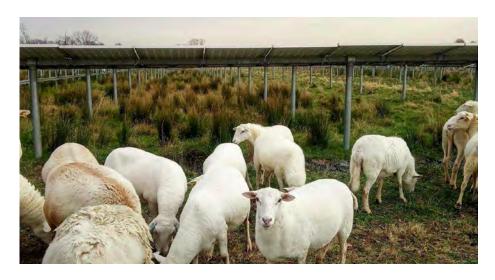
"Solar Grazing" is a method of vegetation control for solar sites that utilizes livestock. Sheep are best suited due to their size and grazing behavior. Ground cover is established with a "Fuzz and Buzz" mix that is conducive to grazing as well as pollinating. Projects such as the proposed Old Glebe Point Rd. would contract with local sheep farmers to move onto site in the Spring, care for them during grazing season, and move off site in the Winter. Sheep are excellent at grazing under panels where mowing is more labor intensive. The perimeter fence protects sheep from predators and solar panels provide shelter from rain, wind, and direct sun on hot days.

Pivot Energy has established a partnership with United Agrivoltaics to help lead our Solar Grazing initiatives. With a network of sites across the country and partners in Solar Grazing since 2015, United Agrivoltaics will assist Pivot Energy in a vegetative maintenance plan for this dual use.

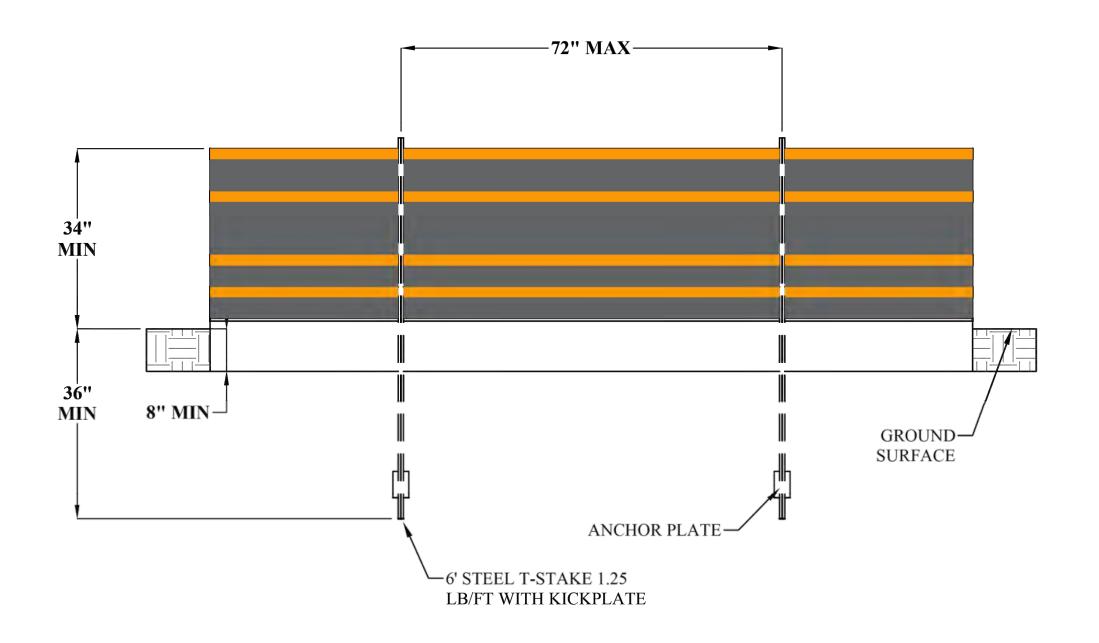
INSTALLATION INSTRUCTIONS:

STEP 1: EXCAVATE TRENCH

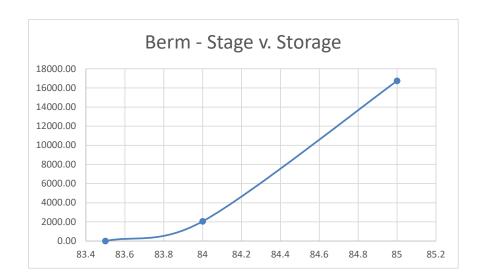
Berm "A" Stage Storage

STAGE	VOID	TOTAL
	AREA	ELEV	VOLUME	RATIO	STORAGE
BOTTOM	0	83.5			0.00
	8228	84	2057.00	1.0	2057.00
	21112	85	14670.00	1.0	16727.00

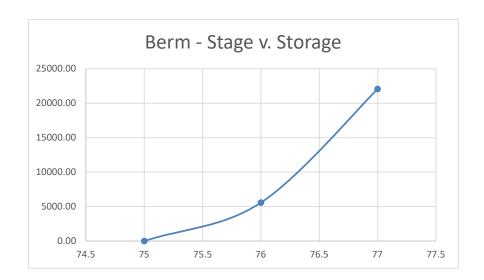
Berm "B" Stage Storage

STAGE	VOID	TOTAL
	AREA	ELEV	VOLUME	RATIO	STORAGE
BOTTOM	0	75			0.00
	11117	76	5558.50	1.0	5558.50
	21880	77	16498.50	1.0	22057.00

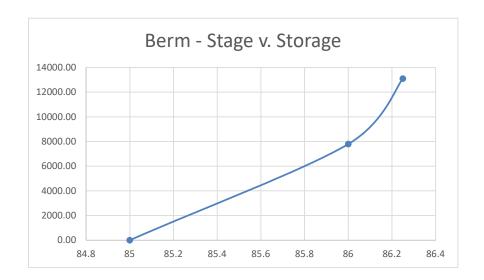
Berm "C" Stage Storage

STAGE	VOID	TOTAL
	AREA	ELEV	VOLUME	RATIO	STORAGE
BOTTOM	0	85			0.00
	15585	86	7792.50	1.0	7792.50
EMBANKMENT	26765	86.25	5293.75	1.0	13086.25

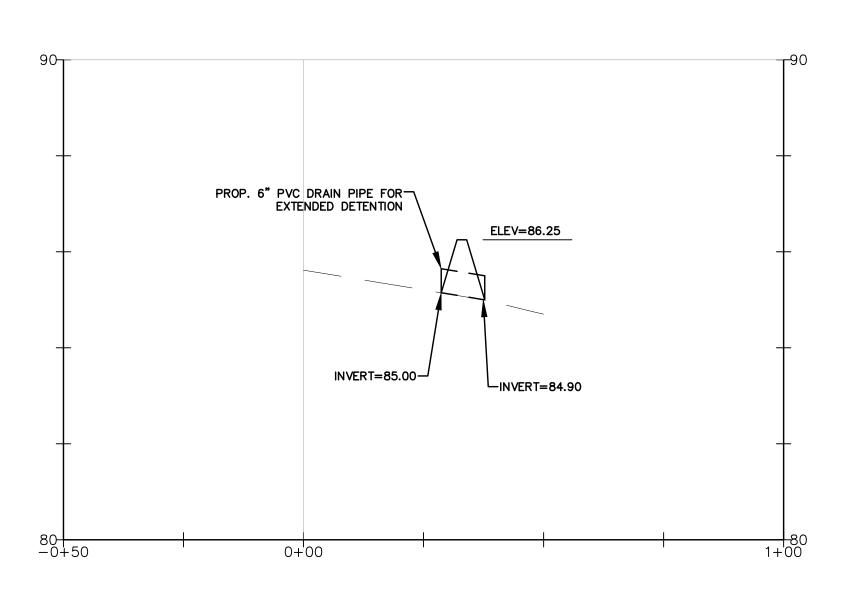
2 EXTENDED DETENTION "C" SECTION

SCALE: 1" = 20' (HOR) 1" = 2' (VER)

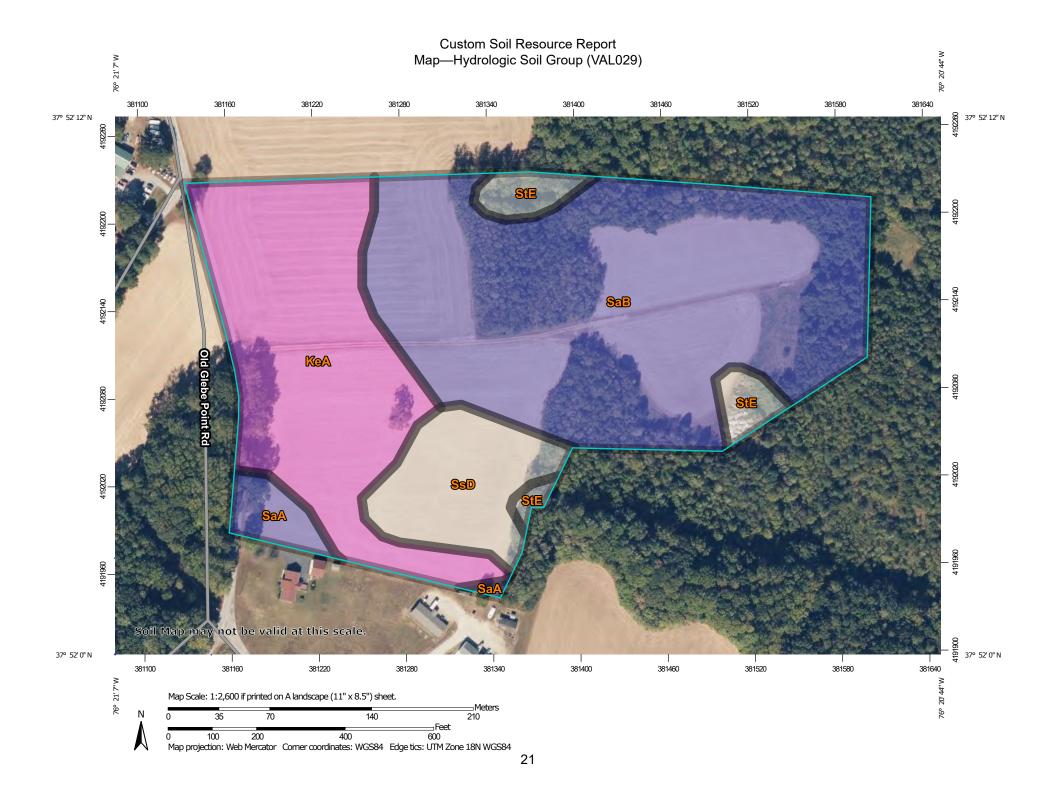
Group D. Soils having a very slow infiltration rate (high runoff potential) when thoroughly wet. These consist chiefly of clays that have a high shrink-swell potential, soils that have a high water table, soils that have a claypan or clay layer at or near the surface, and soils that are shallow over nearly impervious material. These soils have a very slow rate of water transmission.

If a soil is assigned to a dual hydrologic group (A/D, B/D, or C/D), the first letter is for drained areas and the second is for undrained areas. Only the soils that in their natural condition are in group D are assigned to dual classes.

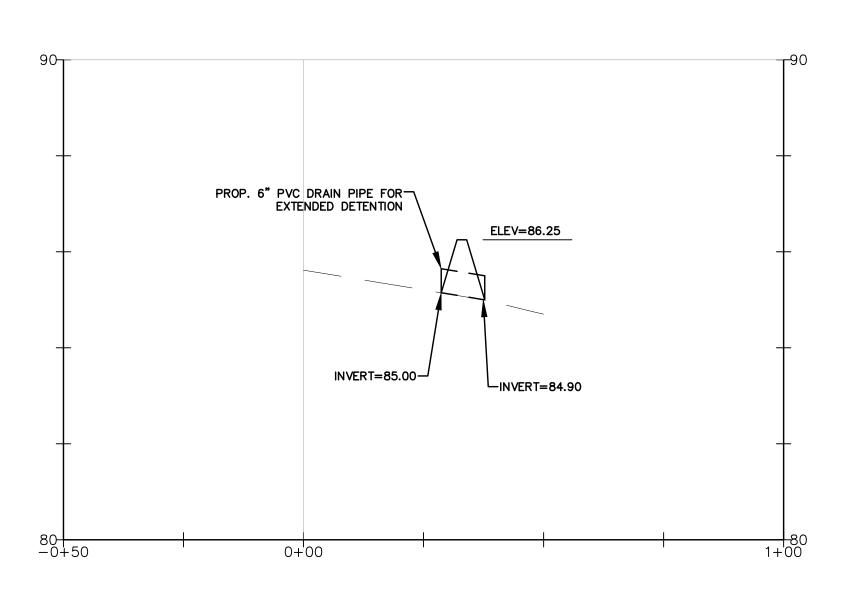
2 EXTENDED DETENTION "C" SECTION

SCALE: 1" = 20' (HOR) 1" = 2' (VER)

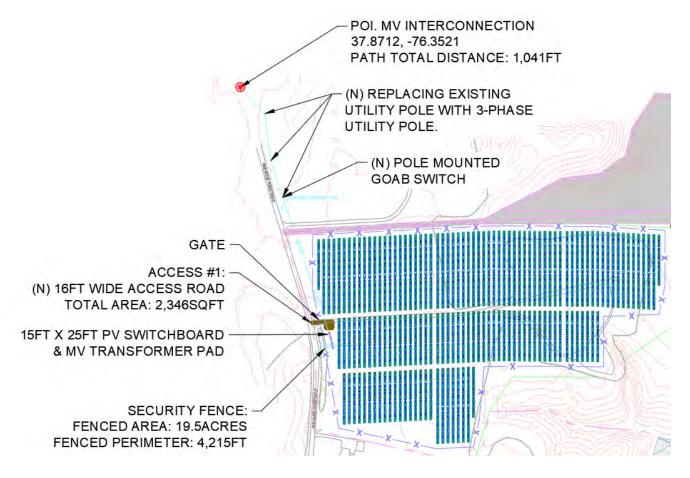
Figure 1. Site Access Locations

Emergency response vehicles should utilize the proposed 16-feet-wide gravel driveway off the east side of Old Glebe Point Road, located approximately 375 feet southeast of the intersection with Pine Circle. This is identified as ACCESS #1 in Figure 1 below. This driveway extends east to the main 16-feet-wide security gate, identified as GATE in Figure 1. This gate is locked with a Knox Box. Just past this gate, the gravel access road extends to the main equipment pad which hosts the MV transformer and the PV switchboard.

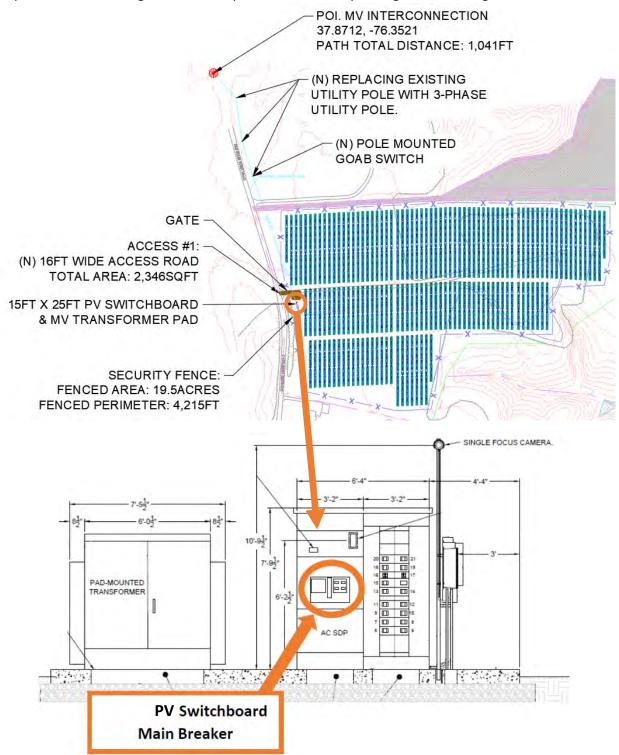
Figure 2 – Emergency Shutdown Switch Location

First responders can de-energize the AC components of the Array through the following device:
